### Bullnose Tile on top of Existing Tile

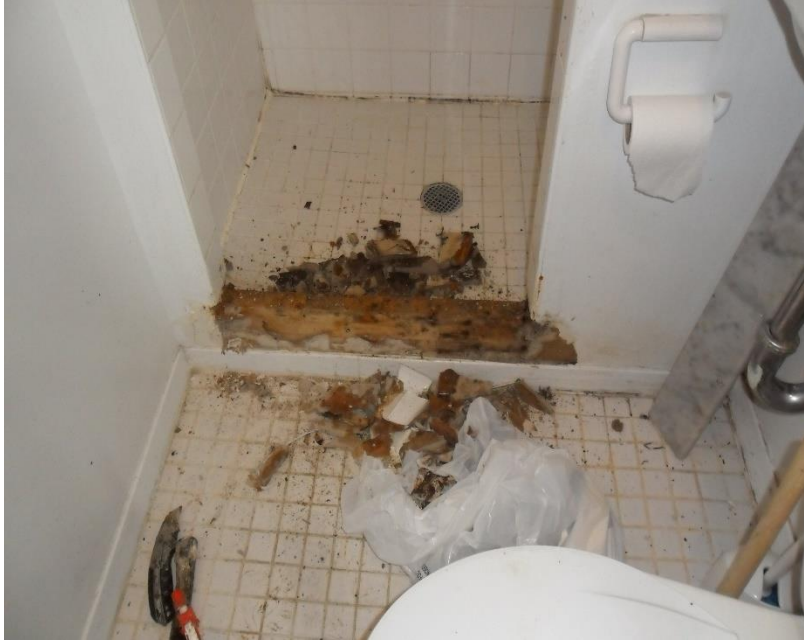
The tenants had moved out, and I was assigned the task of refurbishing the bathroom. When I arrived, the air was thick with the pungent aroma of mold and mildew. I pulled off the marble saddle and discovered the green-board had become saturated. Good Golly what a mess. This bathroom was going to take a lot of work.

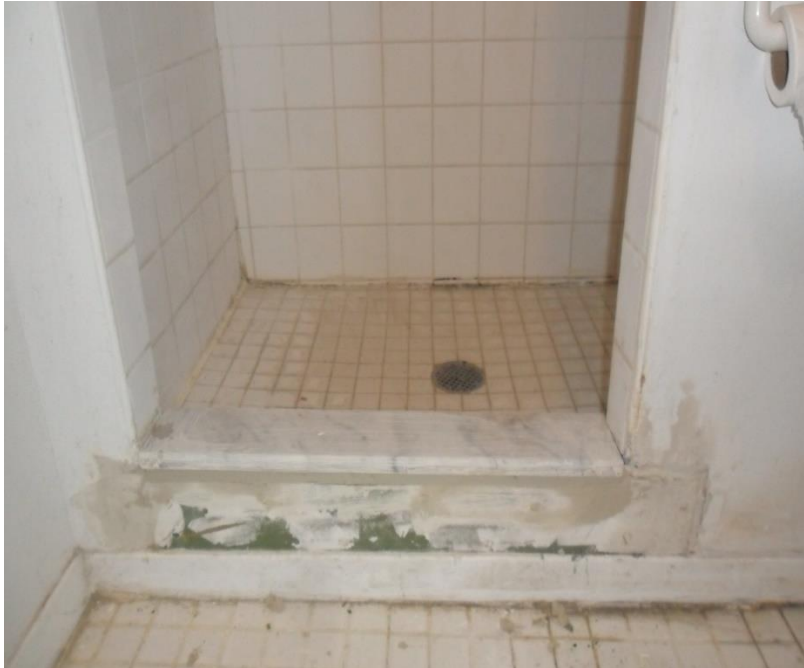
The step below the saddle was completely damaged. I had to cut loose all of the waterlogged gypsum, and discard of it. The 2 X 4 was not damaged, so it was allowed drying conditions.

I covered the 2 X 4 with cementboard, and green board on the outside. The saddle was adhered with thinset mortar.

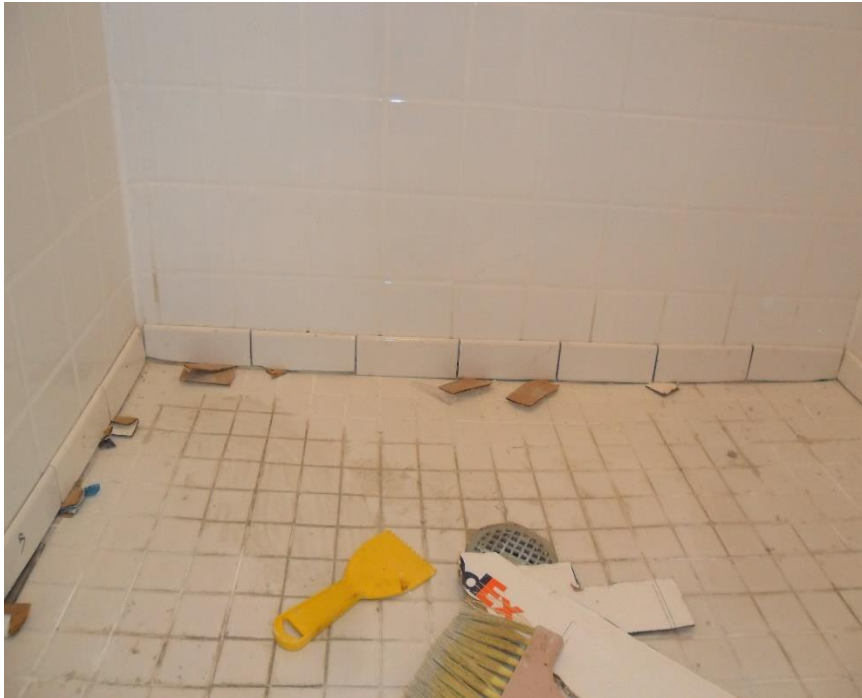
The bottom section of the shower stall was pitched uneven, and there were originally thin strips of tile used - which creates an excessive amount of grout lines which is prone to mold and mildew.
